# Second Five - Year Review Report

## CERCLA Sites at Naval Submarine Base New London

Groton, Connecticut

December 2006

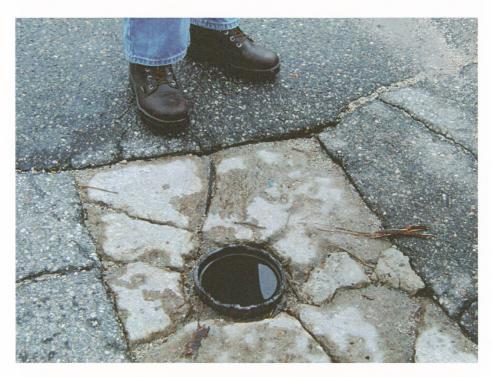
SITE 2 – AREA A LANDFILL AND WETLAND
DETERIORATED CONDITION OF MONITORING WELL 2LMW20D
APRIL 4, 2006
NSB-NLON, GROTON, CONNECTICUT. CTO 038

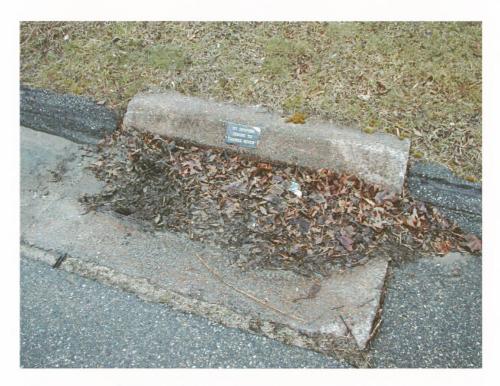
SITE 2 – AREA A LANDFILL AND WETLAND
SEDIMENT AND DEBRIS COVERING THRESHER AVENUE CATCH BASIN
APRIL 4, 2006
NSB-NLON, GROTON, CONNECTICUT. CTO 038

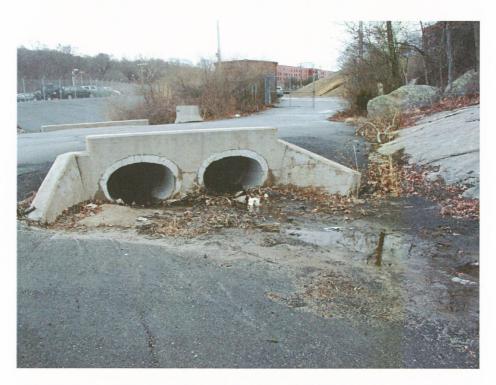
SITE 2 – AREA A LANDFILL AND WETLAND INLET OF CULVERT 2 FACING NORTHEAST APRIL 4, 2006
NSB-NLON, GROTON, CONNECTICUT. CTO 038

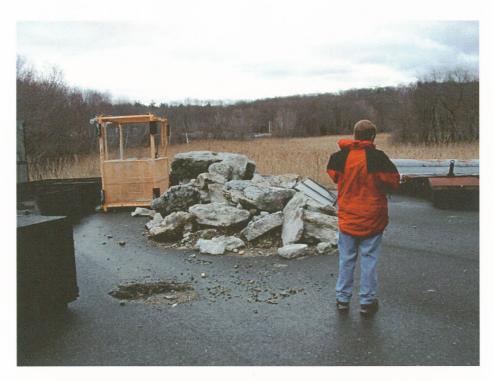
SITE 2 – AREA A LANDFILL AND WETLAND
IMPROPERLY DUMPED CONCRETE RUBBLE ON CAP IN
NORTH-WESTERN PART OF CAP
APRIL 4, 2006
NSB-NLON, GROTON, CONNECTICUT. CTO 038

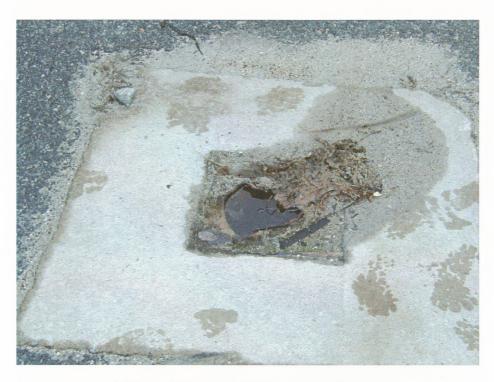
SITE 2 – AREA A LANDFILL AND WETLAND DETERIORATED CONDITION OF 2LMW8S APRIL 4, 2006 NSB-NLON, GROTON, CONNECTICUT. CTO 038

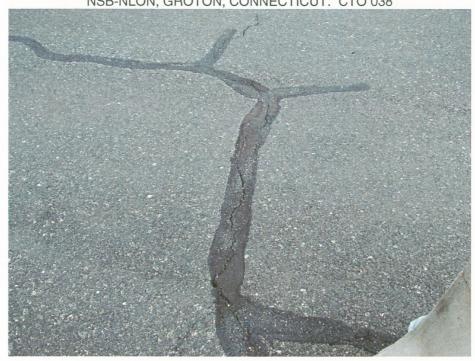
SITE 2 – AREA A LANDFILL AND WETLAND SEALED CRACKS IN CAP PAVEMENT APRIL 4, 2006 NSB-NLON, GROTON, CONNECTICUT. CTO 038

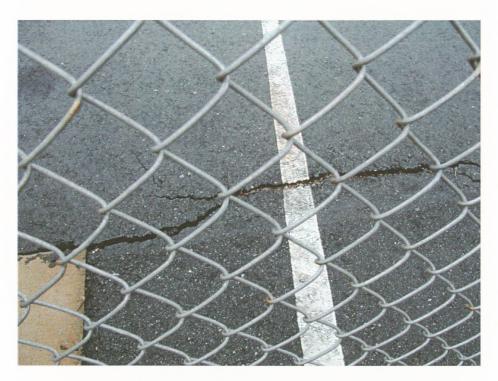
SITE 2 – AREA A LANDFILL AND WETLAND CRACKS IN DEPLOYED PARKING AREA PAVEMENT APRIL 4, 2006 NSB-NLON, GROTON, CONNECTICUT. CTO 038

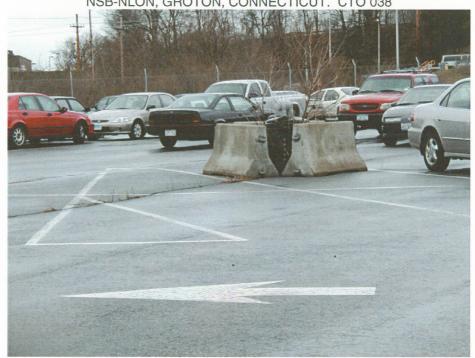
SITE 2 – AREA A LANDFILL AND WETLAND TREE GROWING IN GAS VENT-27 APRIL 4, 2006 NSB-NLON, GROTON, CONNECTICUT. CTO 038

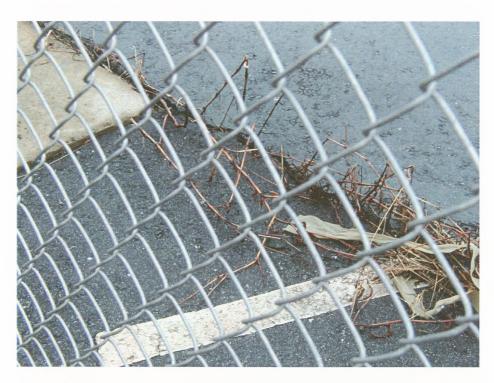
SITE 2 – AREA A LANDFILL AND WETLAND VEGETATION IN CRACK AT DEPLOYED PARKING AREA APRIL 4, 2006 NSB-NLON, GROTON, CONNECTICUT. CTO 038

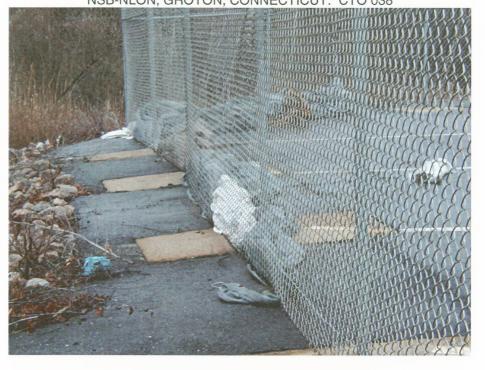
SITE 2 – AREA A LANDFILL AND WETLAND
DEBRIS AGAINST FENCE AND FENCE DETACHED AT BOTTOM
IN DEPLOYED PARKING AREA
APRIL 4, 2006
NSB-NLON, GROTON, CONNECTICUT. CTO 038

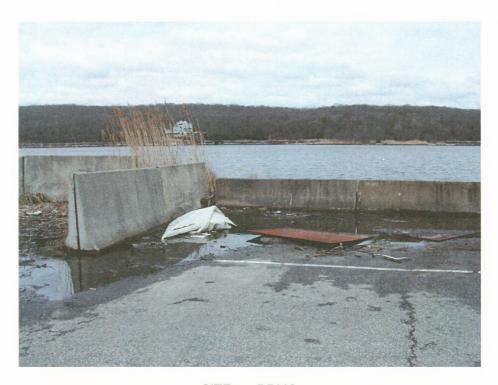
SITE 6 – DRMO
DEBRIS AND PONDED WATER ON SOUTHWEST CORNER OF CAPPED AREA
APRIL 4, 2006
NSB-NLON, GROTON, CONNECTICUT. CTO 038

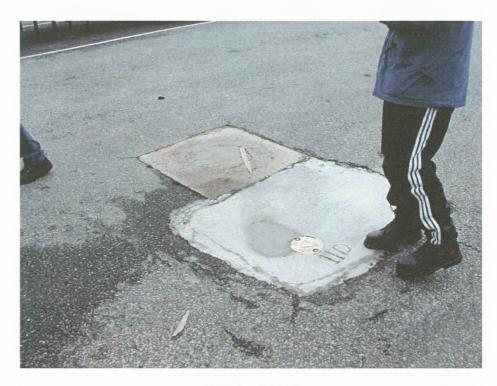
SITE 6 – DRMO
NEW CONCRETE PAD FOR MONITORING WELL 6MW11D
APRIL 4, 2006
NSB-NLON, GROTON, CONNECTICUT. CTO 038

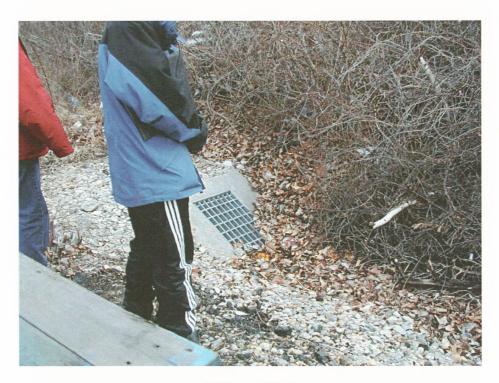
SITE 6 – DRMO
DROP INLET WITH GRATE AT NORTHERN END OF CAPPED AREA
APRIL 4, 2006
NSB-NLON, GROTON, CONNECTICUT. CTO 038

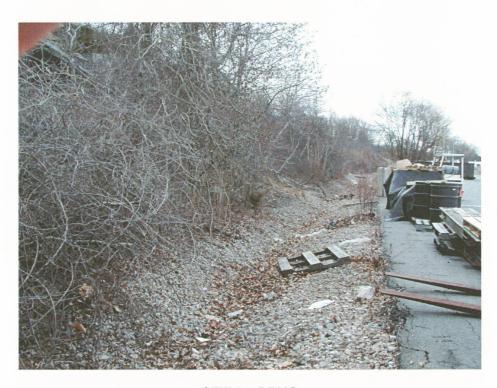
SITE 6 – DRMO
PERIMETER CHANNEL ALONG EASTERN SIDE OF CAPPED AREA
APRIL 4, 2006
NSB-NLON, GROTON, CONNECTICUT. CTO 038

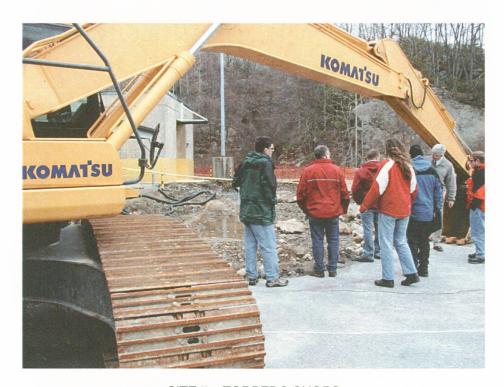
SITE 7 – TORPEDO SHOPS
EXCAVATION ALONG SOUTHERN SIDE OF BUILDING 325 FACING EAST
APRIL 4, 2006
NSB-NLON, GROTON, CONNECTICUT. CTO 038

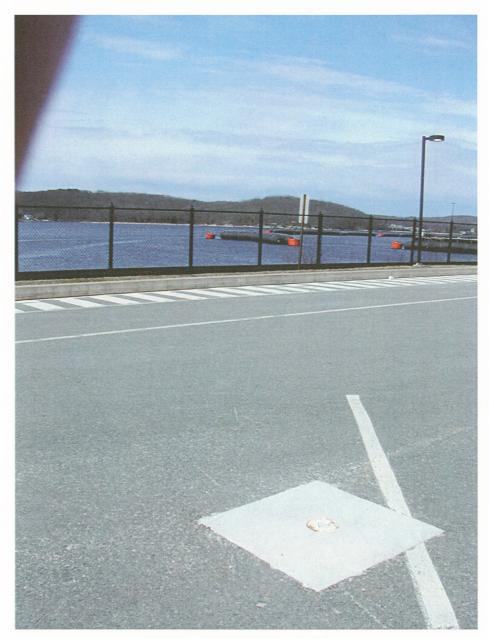
SITE 8 – GOSS COVE LANDFILL
NEW CONCRETE PAD AT MONITORING WELL 8MW2D
LOOKING WEST
APRIL 3, 2006
NSB-NLON, GROTON, CONNECTICUT. CTO 038

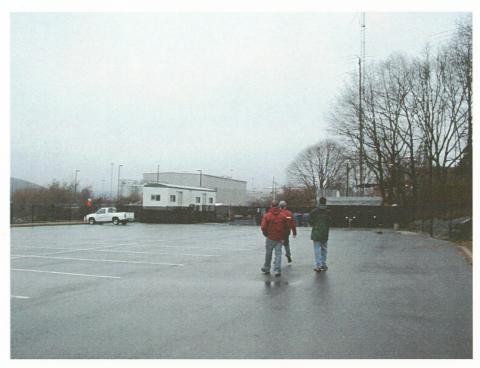
SITE 8 – GOSS COVE LANDFILL LOOKING NORTH AT FENCED MAINTENANCE BUILDING HAZARDOUS MATERIALS BEING STORED IN UNLOCKED STORAGE LOCKERS APRIL 4, 2006 NSB-NLON, GROTON, CONNECTICUT. CTO 038

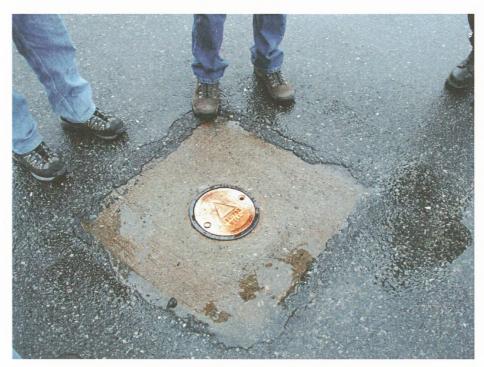
SITE 8 – GOSS COVE LANDFILL
MISSING BOLT IN COVER FOR MONITORING WELL 8MW5S
APRIL 4, 2006
NSB-NLON, GROTON, CONNECTICUT. CTO 038

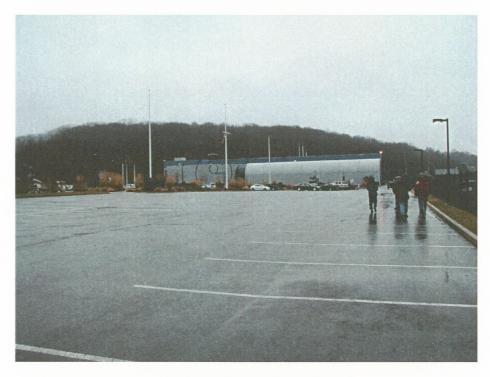
SITE 8 – GOSS COVE LANDFILL LOOKING SOUTH AT CAP AND MUSEUM APRIL 4, 2006 NSB-NLON, GROTON, CONNECTICUT. CTO 038

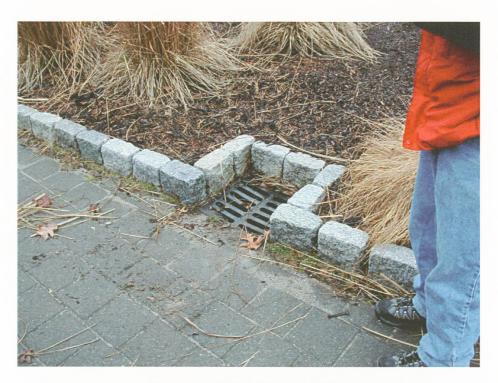
SITE 8 – GOSS COVE LANDFILL VEGETATIVE DEBRIS ON YARD DRAIN #13 APRIL 4, 2006 NSB-NLON, GROTON, CONNECTICUT. CTO 038

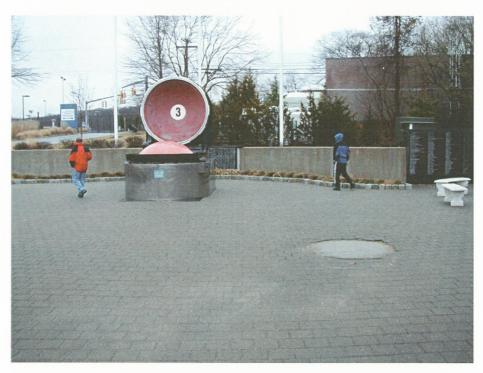
SITE 8 – GOSS COVE LANDFILL
MISSILE HATCH DISPLAY AND FOUNDATION FOR FORMER GUN DISPLAY
LOOKING EAST
APRIL 4, 2006
NSB-NLON, GROTON, CONNECTICUT. CTO 038

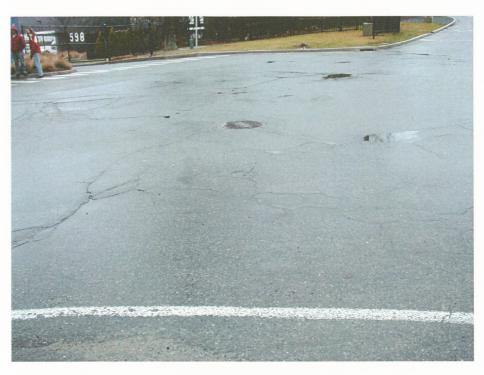
SITE 8 – GOSS COVE LANDFILL LOOKING NORTH AT MONITORING WELL 8MW9S IN CENTER PUDDLE AND APPROXIMATE LOCATION OF MONITORING WELL 8MW10S IN CURBED AREA APRIL 4, 2006 NSB-NLON, GROTON, CONNECTICUT. CTO 038

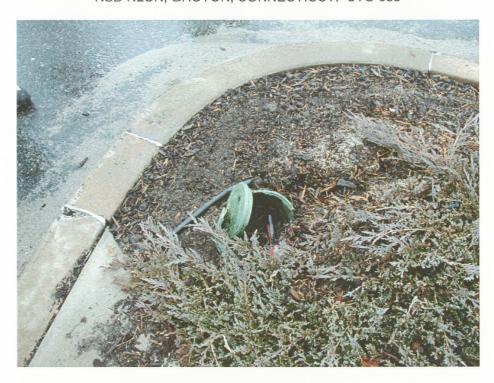
SITE 8 – GOSS COVE LANDFILL
BROKEN SPRINKLER JUNCTION BOX NEAR LIGHT POLE K
LOOKING NORTHWEST
APRIL 4, 2006
NSB-NLON, GROTON, CONNECTICUT. CTO 038

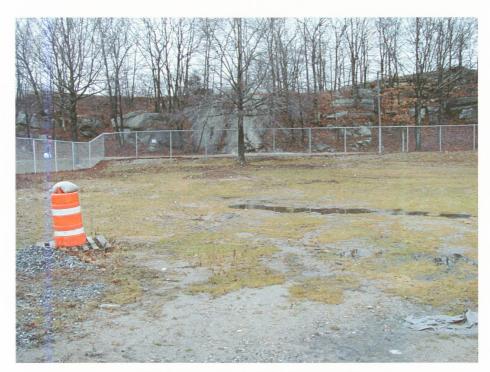
SITES 9/23 – OT-5 AND TANK FARM LOOKING NORTHEAST AT LOCATION OF SITE 9 (OT-5) APRIL 4, 2006 NSB-NLON, GROTON, CONNECTICUT. CTO 038
